דוח ביצוע עבודת שימור ציור קיר של אברהם אופק

בית ספר תל"י בית וגן ירושלים

Conservation and restoration of the Painting of Avraham Ofek

Tali School in Bayit Ve'gan/ Stone in Kiryat Yovel,
in Jerusalem, Volta Ilit St 12

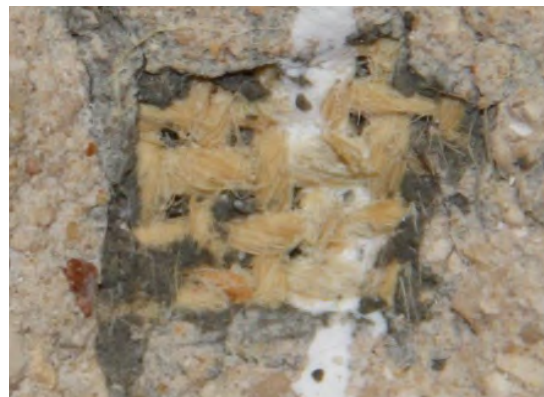
The painting shows two long vertical cracks. In those areas we can see a jute fabric which is incorporated inside the concrete underneath the base plaster layer.

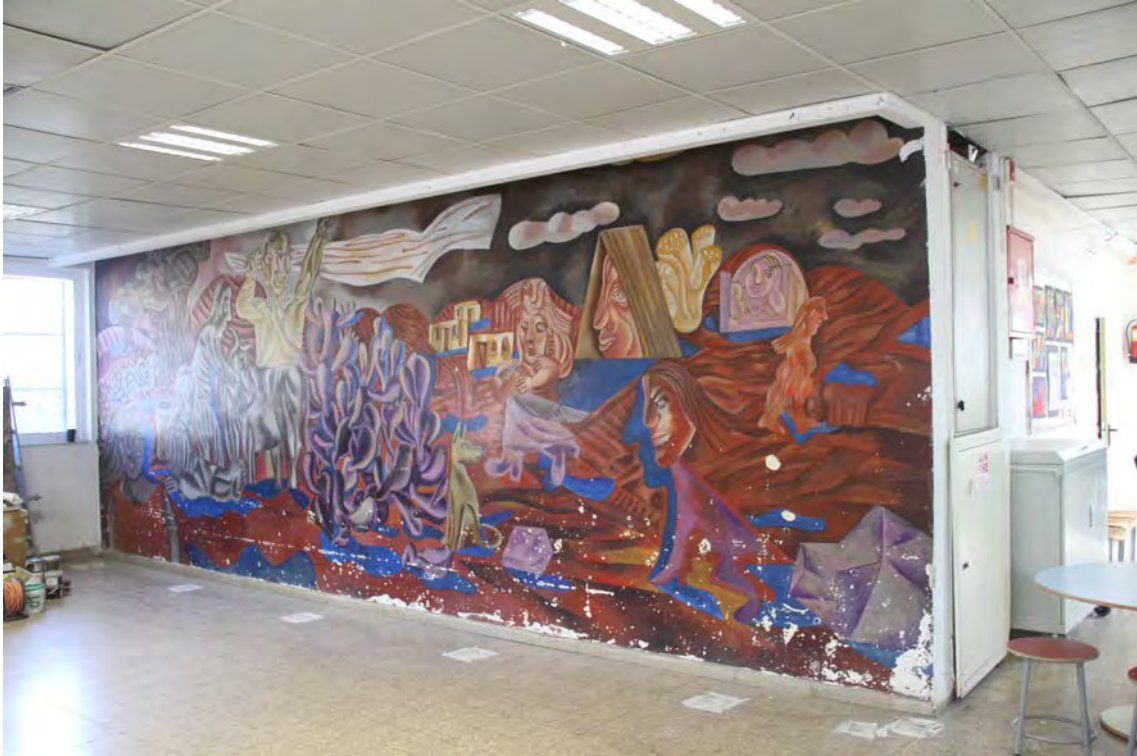
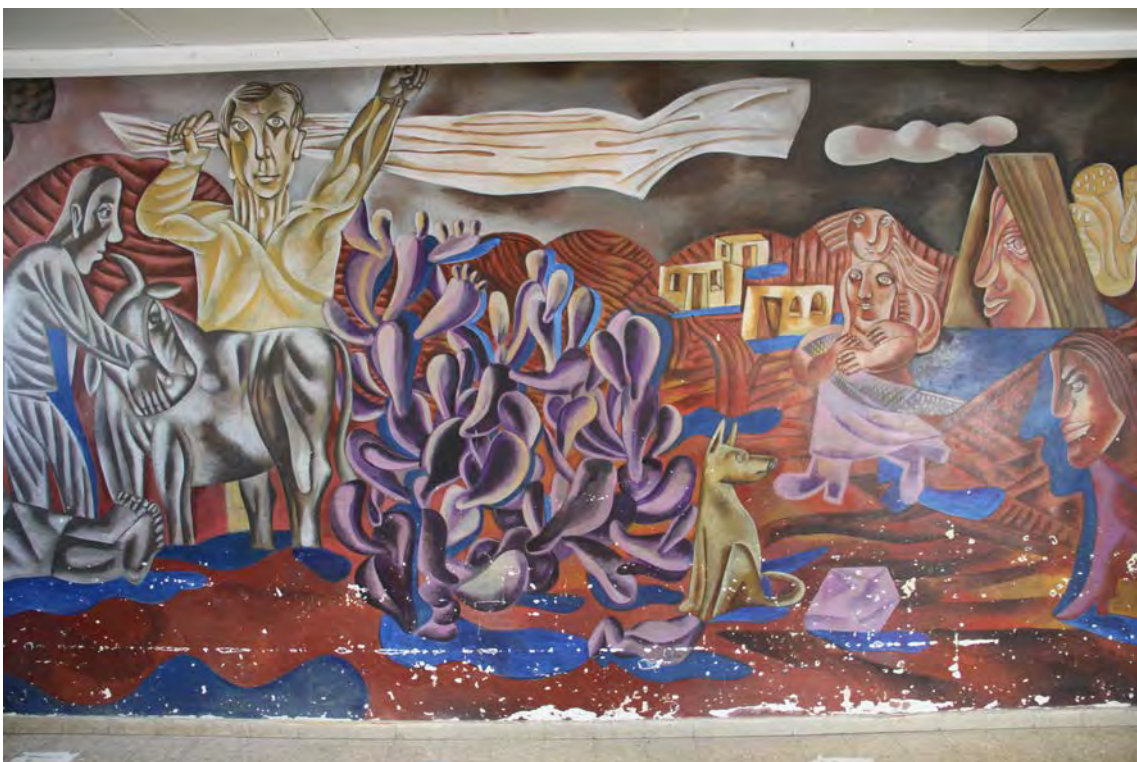
Condition before restoration

Paint and plaster losses

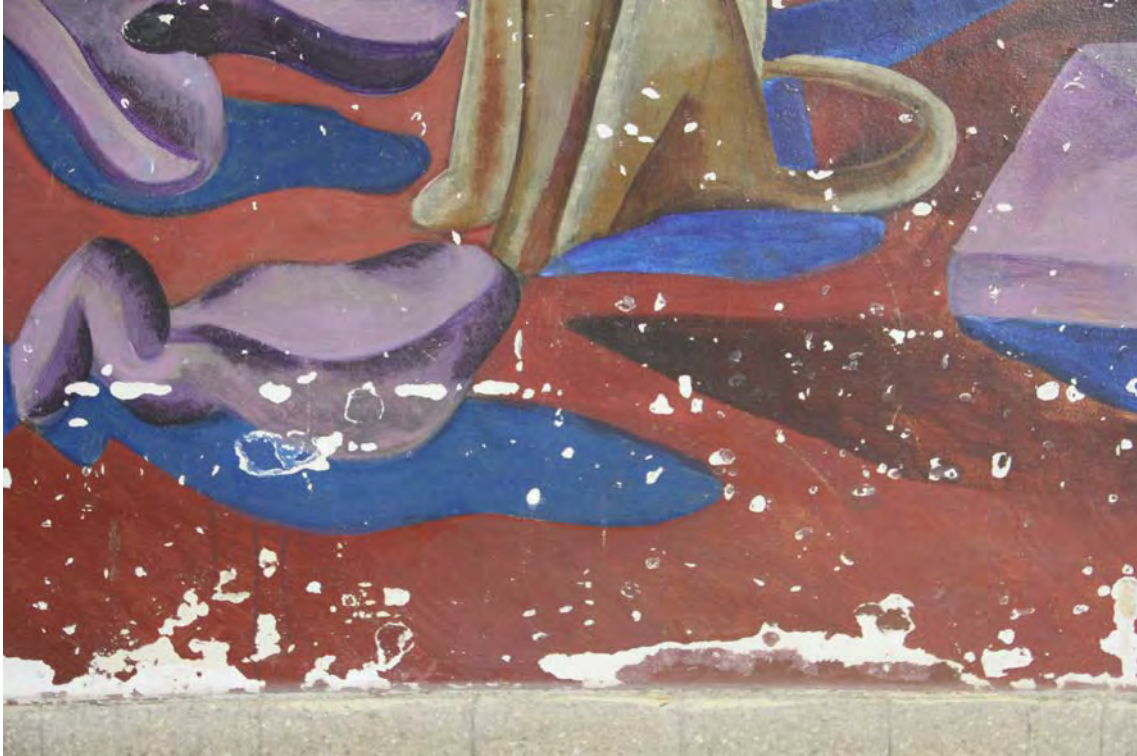
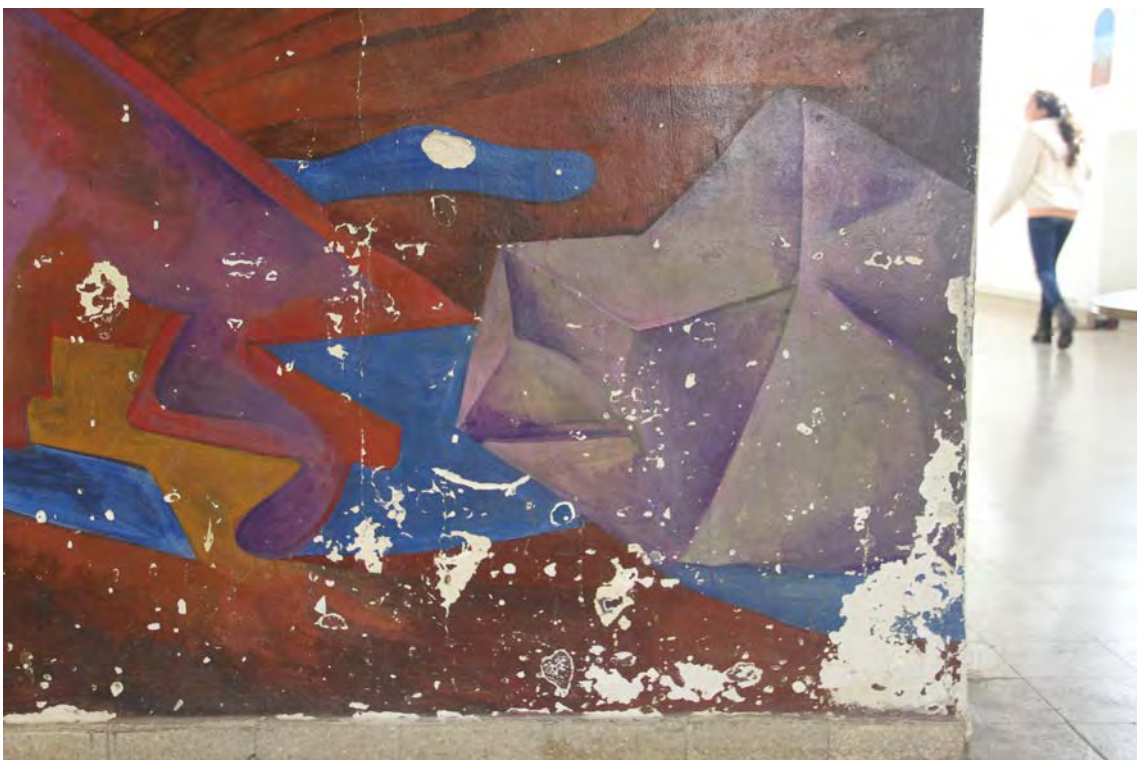
Paint and plaster losses, cracks
Former restoration (lower picture)

The areas of deep plaster losses were selectively consolidated by injecting a lime based injection mortar (Ledan).

Deep plaster losses were filled with a semi coarse lime based mortar (Weber, Finitura).

Losses in the upper coating were filled with a fine chalk based mortar (Merek Spachtel 2000). The fillings were applied with small spatulas and smoothed after drying with a damp sponge.

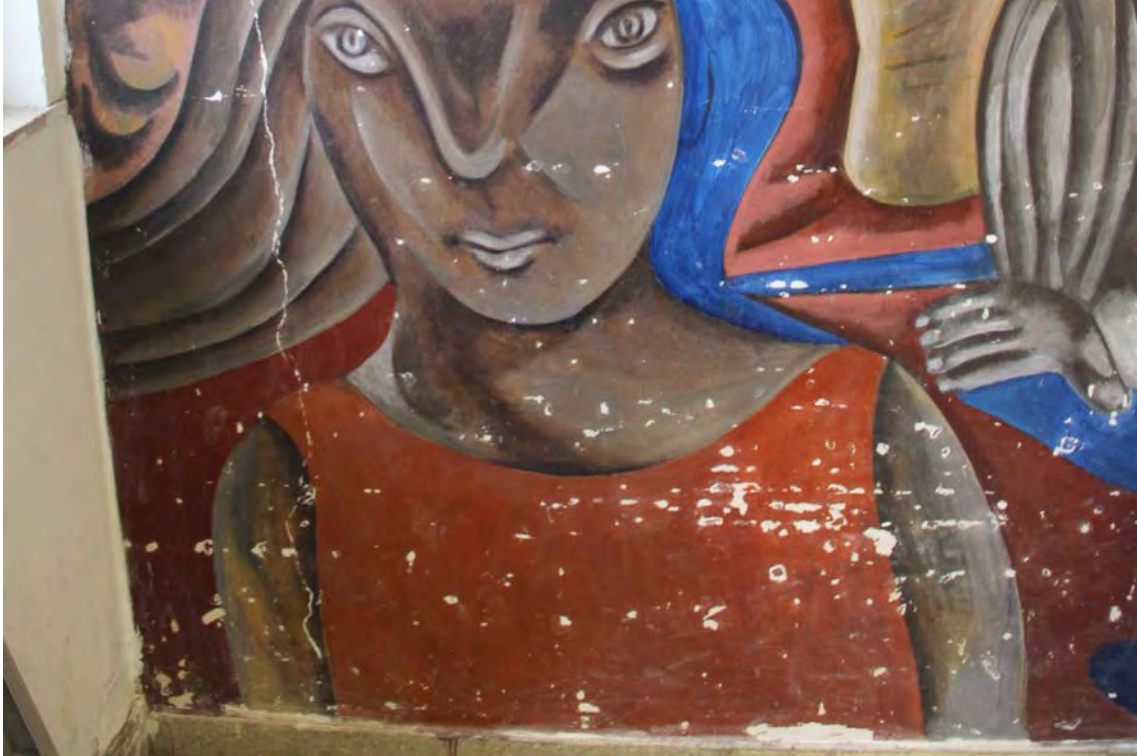
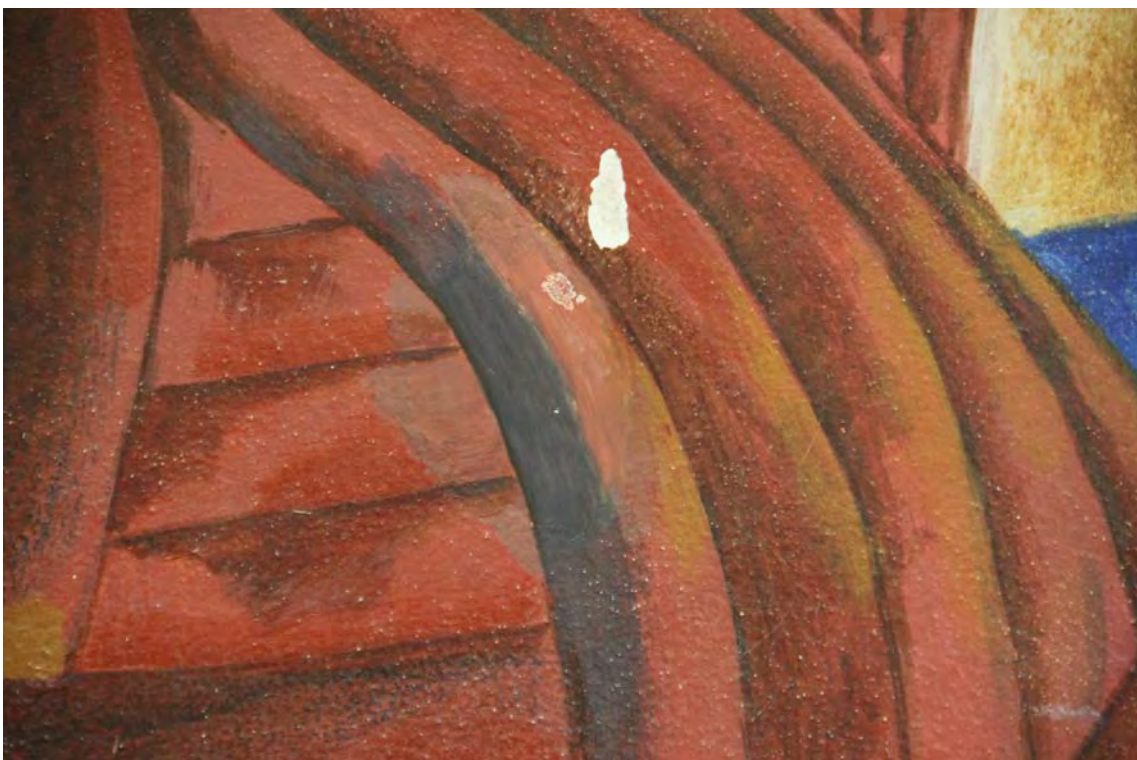
Deeper losses in the base plaster layer
