דוח ביצוע עבודת שימור ציור קיר של אברהם אופק

בית ספר תל"י בית וגן ירושלים

Conservation and restoration of the Painting of Avraham Ofek

Tali School in Bayit Ve'gan/ Stone in Kiryat Yovel,
in Jerusalem, Volta Ilit St 12

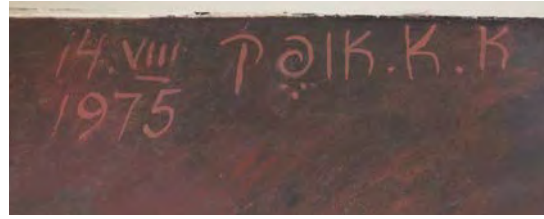
The painting in the entrance hall at the Tali School in Jerusalem was created by the painter Avraham Ofek in 1975 as we can see on his signature in the left upper corner of the painting.

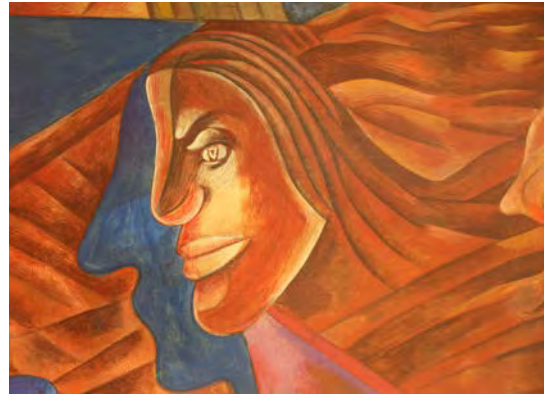
The painting is about 20 square meters in size. It was painted in acrylics. Some areas in the painting are not completely waterproof which leads to the conclusion that the painter painted in several layers and worked with thin diluted paint glazes.

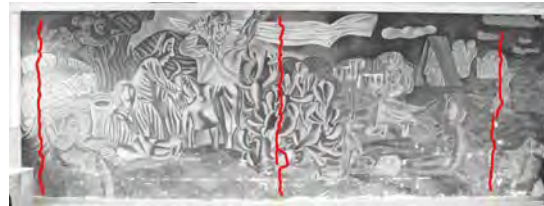
The wall shows a regular preparation which means no specific plasters were used. The construction of the wall seems to be as following:

1. grey concrete
2. coarse grained base plaster layer (about 1 cm thick)
3. thin fine upper coating (about 1 mm thick)

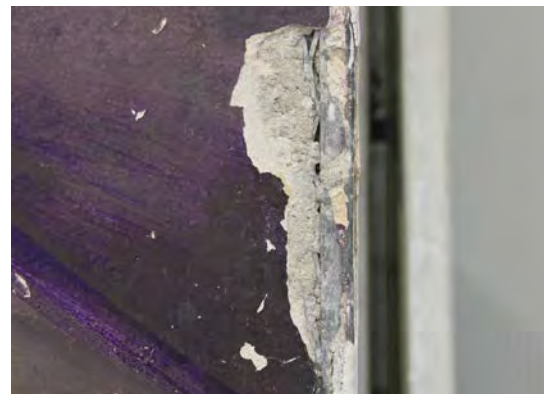
The right corner of the wall was reinforced with a metall armor which seats underneath the base plaster.

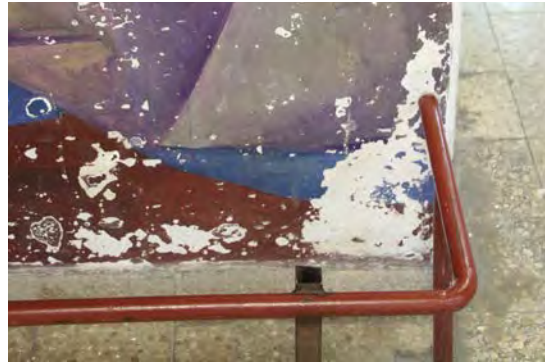
An approximately 40 cm high metall railing which served as protection for the painting was removed and will be replaced by a 1 m (?) high glass railing.

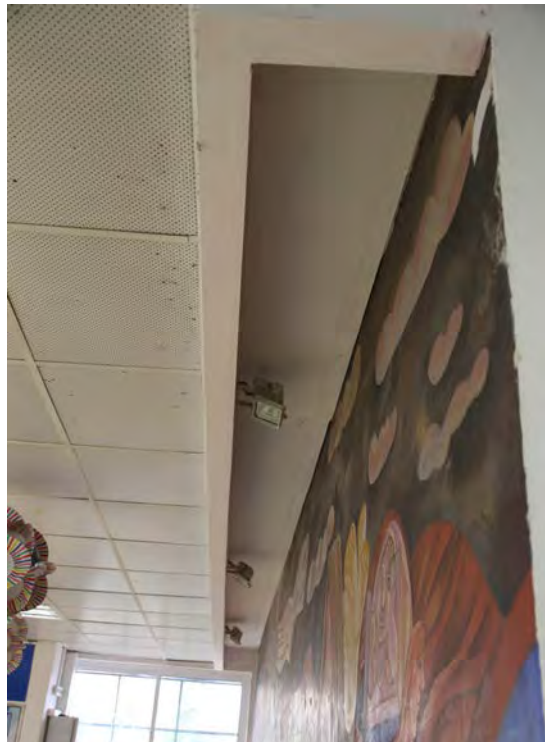
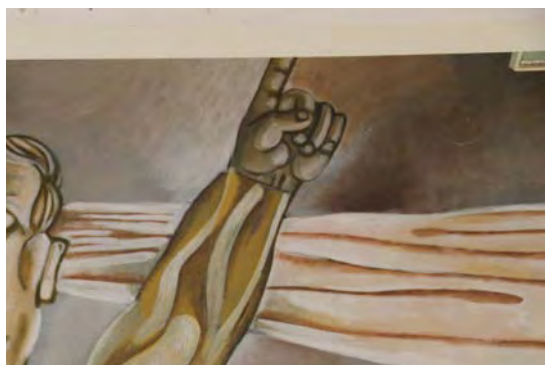
The todays construction of the ceiling is covering the last upper centimeters of the painting.

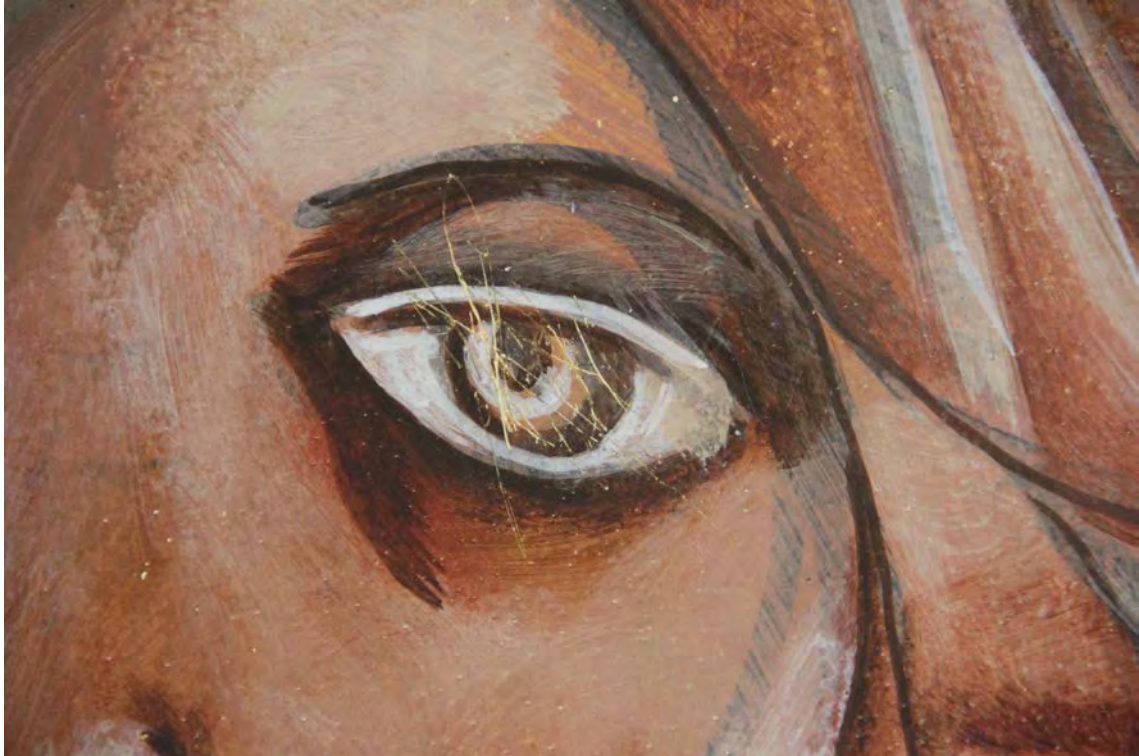
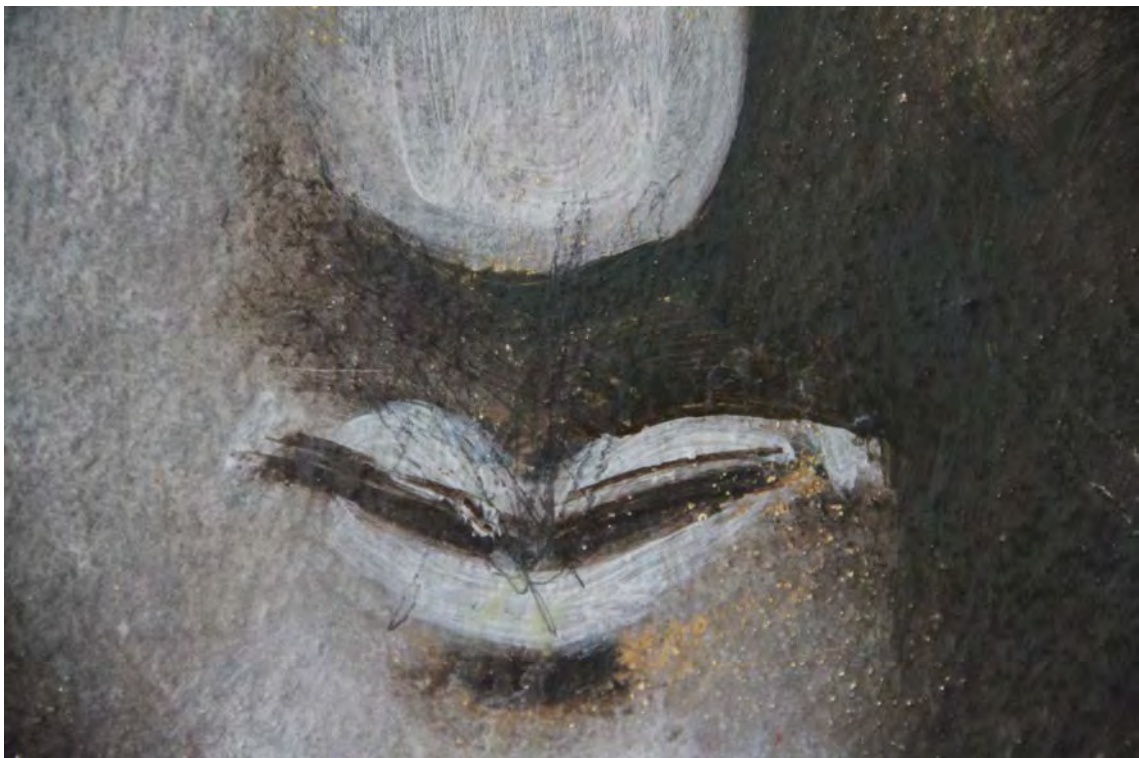
Further damages are scratches, pencil strokes and writings and stains of white wall paint which were smeared over the painting. The painting surface is dusty.

Scratches and pencil writings

Pencil strokes and writings could be removed by using a regular pencil eraser.
